Appendix F

Structures Inspection Results

FACILITIES CONDITION ASSESSMENT REPORT

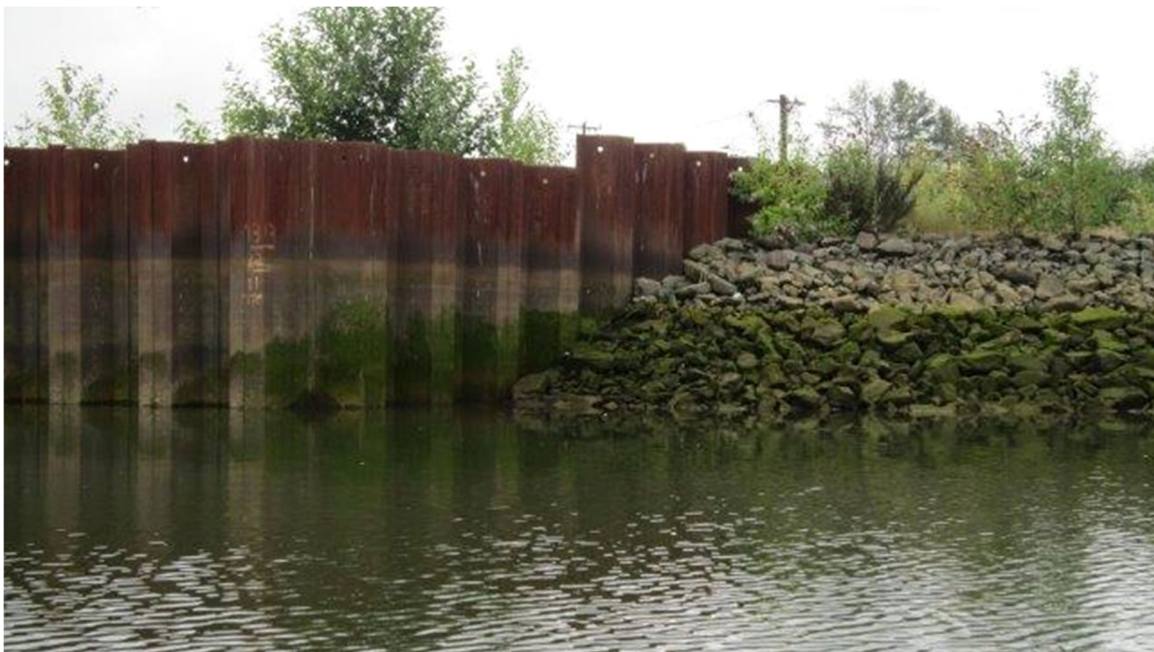
- Structure consists of U-shaped steel sheet pile bulkhead for contamination containment of Terminal 117 Cleanup Site.
- The sheet piles appear to be in good condition. (Photos 1 to 4)
- The North and South return walls abut riprap river bank embankment. (Photos 1 to 4)
- Near the north end of the bulkhead, four (4) 12" diameter steel pipe guide piles support for a 16" diameter float debris deflection pile pipe. The piles and float are in good condition. (Photos 2 and 3)
- During the July 12, 2021 inspection we observed, under construction, what appears to be an elevated concrete walkway deck supported by steel pipe piers. (Photo 5)
- The walkway is in-water, along the west shoreline and south of the South Park Marina.

Photo ST19-04: North Return Wall (Looking West)

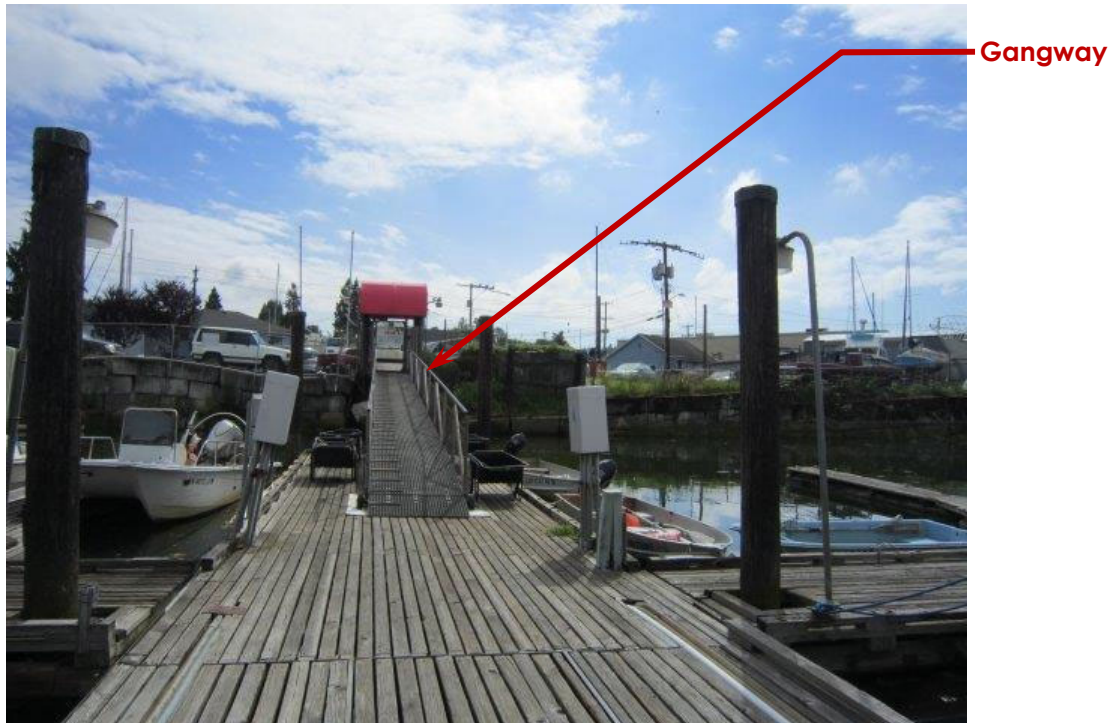
- The galvanized steel pipe truss gangway is supported on the west end but the type and condition of the support is unknown (Photo 9).
- Utilities servicing the marina are hung on the west end of the gangway and fed from under the gangway. The integrity of the pull box cantenary supports is not known (Photos 10 and 11).
- There is scattered rust along the length of the truss members and corrosion at several welded joints (Photos 10 and 11).
- The wood walkway decking is worn and weathered but no distress was observed.
- The slip resistant grating over the decking appears to be in good condition.

Photo ST20-09: Gangway and Walkway (Looking West)

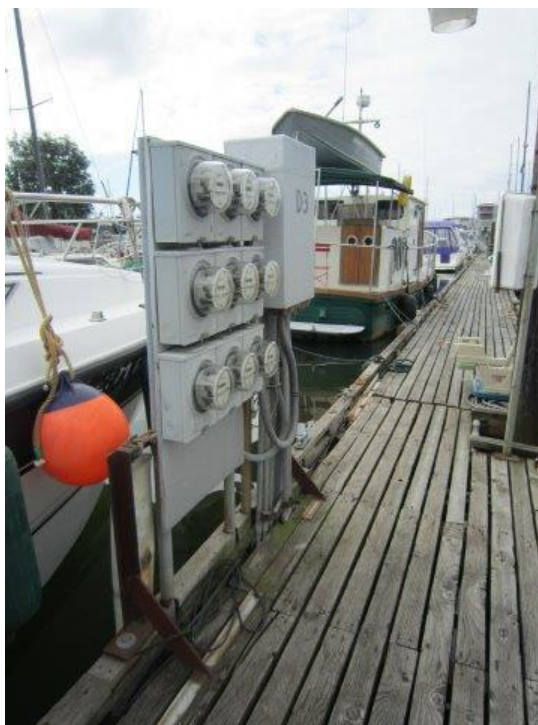
- The walkway, docks, and finger piers timber decking are worn and weathered. A number of planks appear to have been replaced, missing, re-fastened. Except for scattered dead or lost knots and checks no evidence of rot, moss growth, splinters, or perceptible deflection was observed (Photos 12 to 19).
- Utilities on the dock include power, water, and cable (Photo 14 and 15).

Photo ST20-014: Utilities

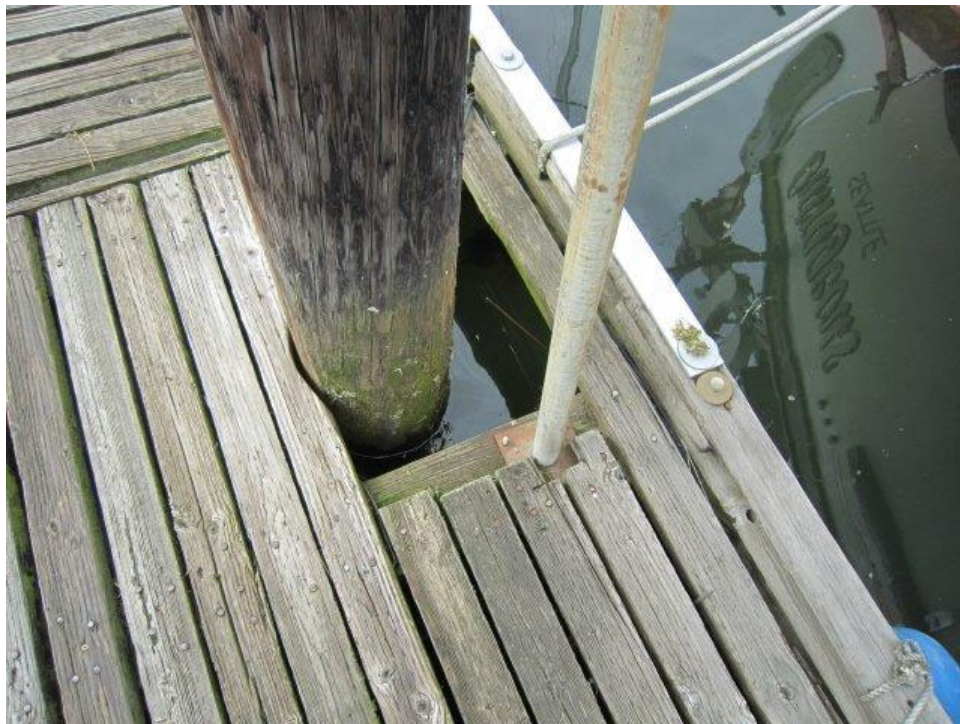
Photo ST20-17: Float Guide

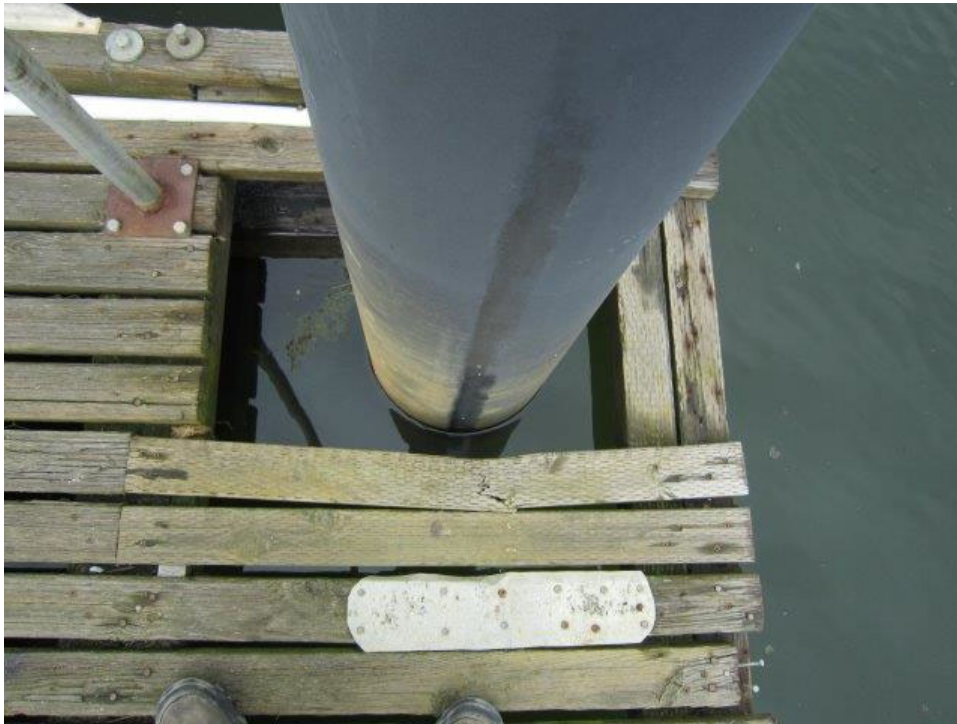
Photo ST20-19: Float Guide

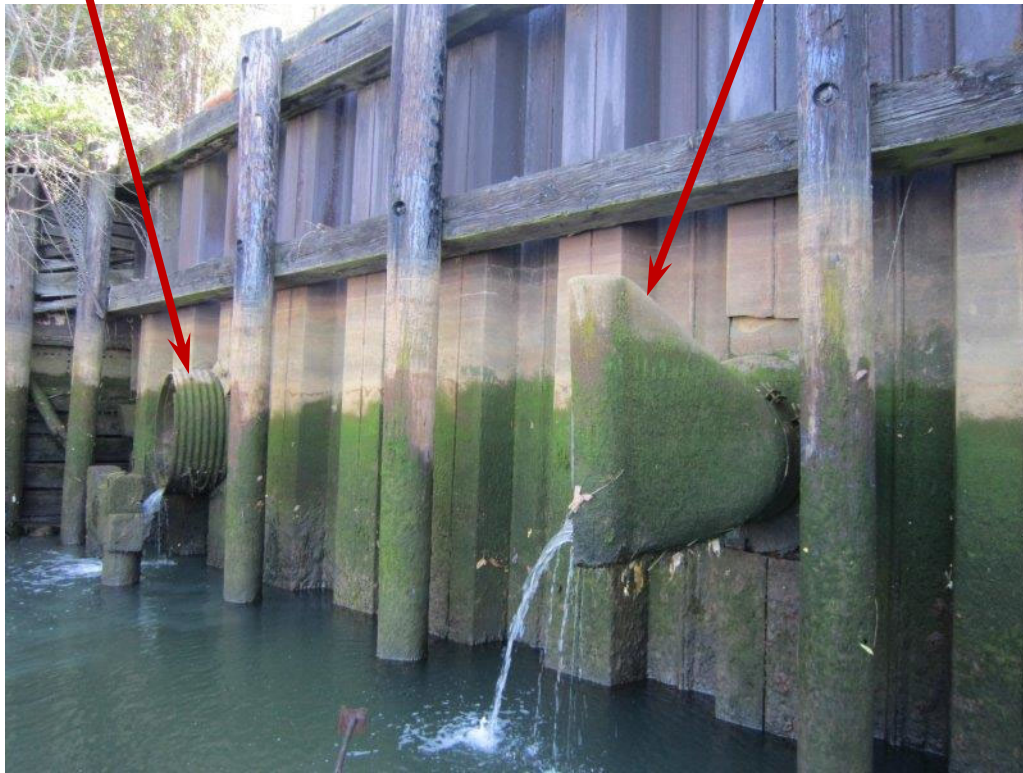
2061-01: Outfall at Low Tide

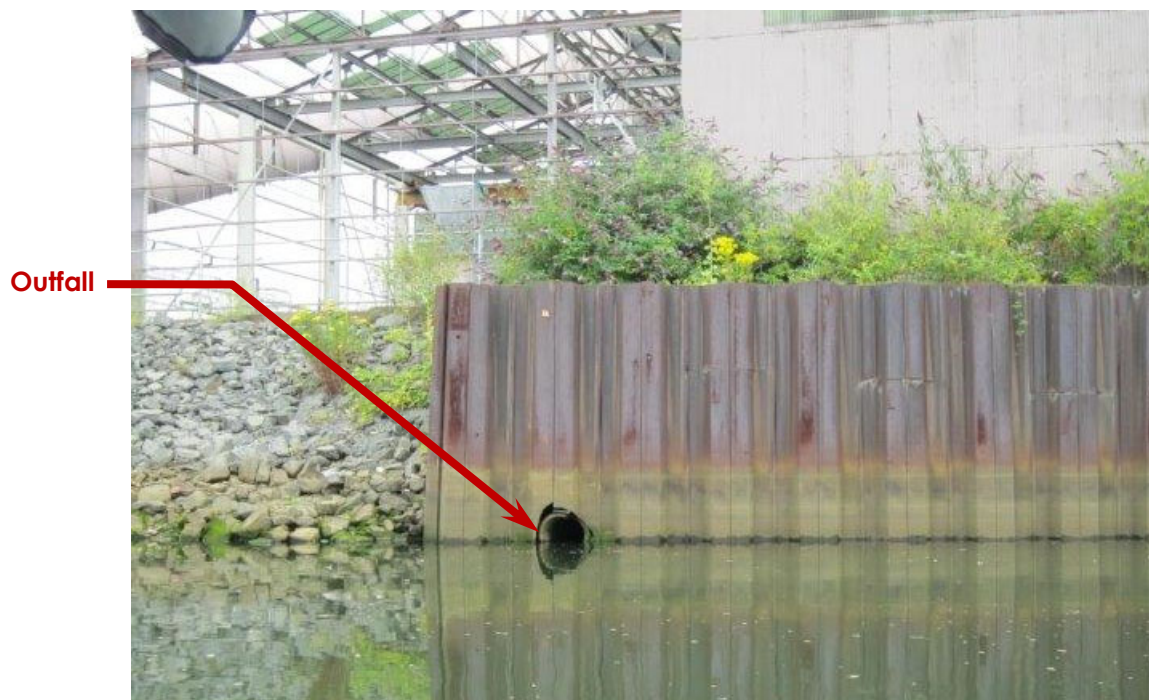
- Outfall end is supported by and approximately flush with steel sheet pile bulkhead (Photos 1 to 3).
- Outfall is 18-inch-diameter open-ended concrete pipe surrounded by rock backfill behind the sheet pile.
- South half of pipe is broken at the end.
- Outfall appears to be operational.

2072-02: Concrete Outfall at High Tide

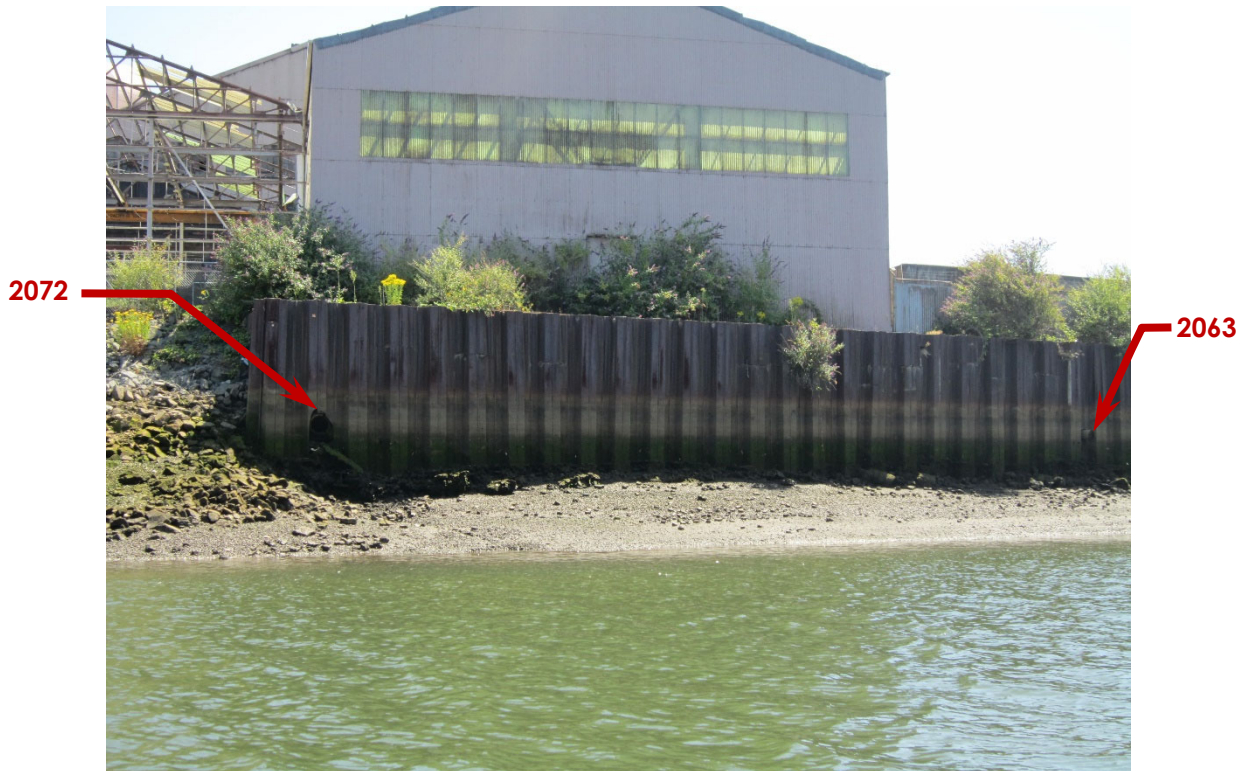
2063-01

- Outfall is 12-inch-diameter open-ended corrugated metal (steel) pipe (CMP). Pipe material is in good condition (Photos 1 to 4).
- Pipe supported by and overhangs the sheet pile bulkhead.
- Outfall is plugged with concrete and appears abandoned although slow drips were observed.

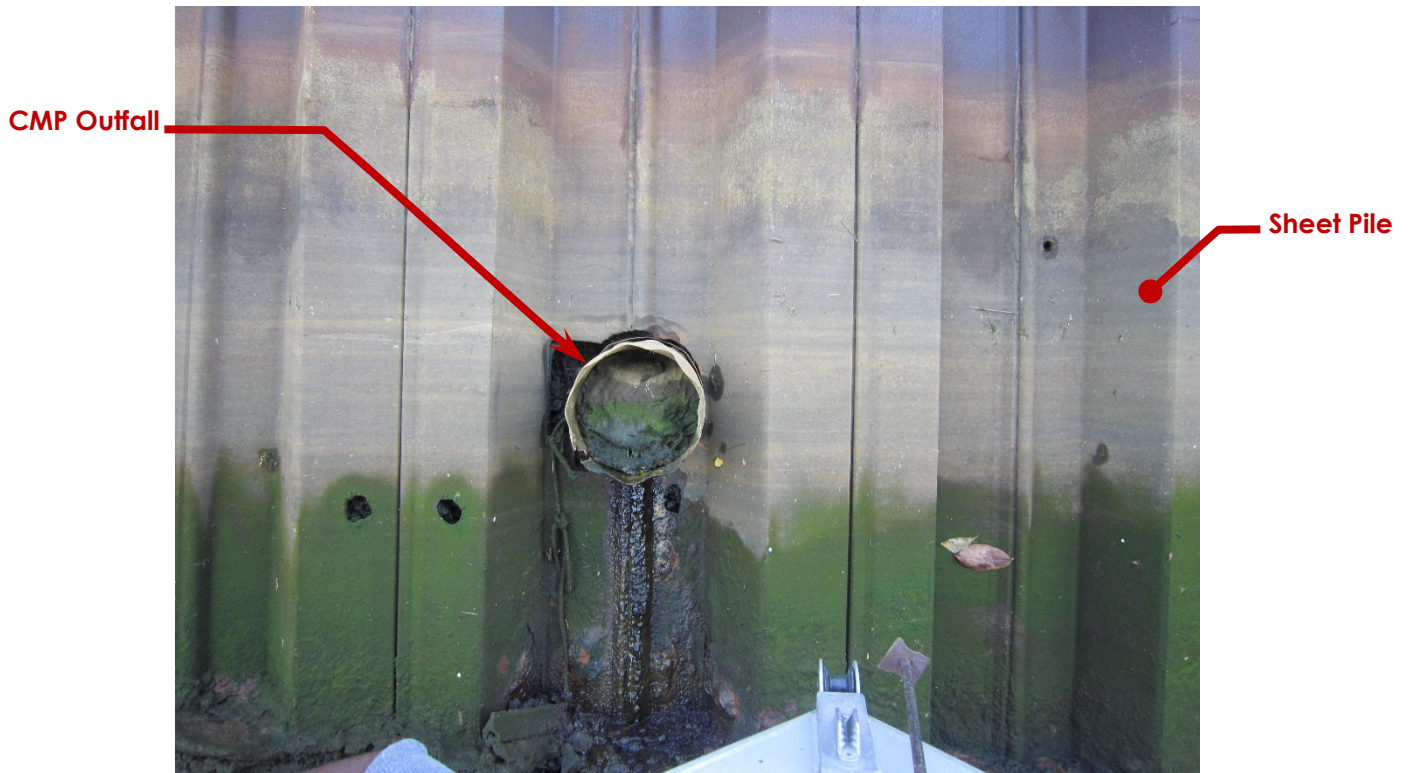
2063-03: Outfall at Low Tide

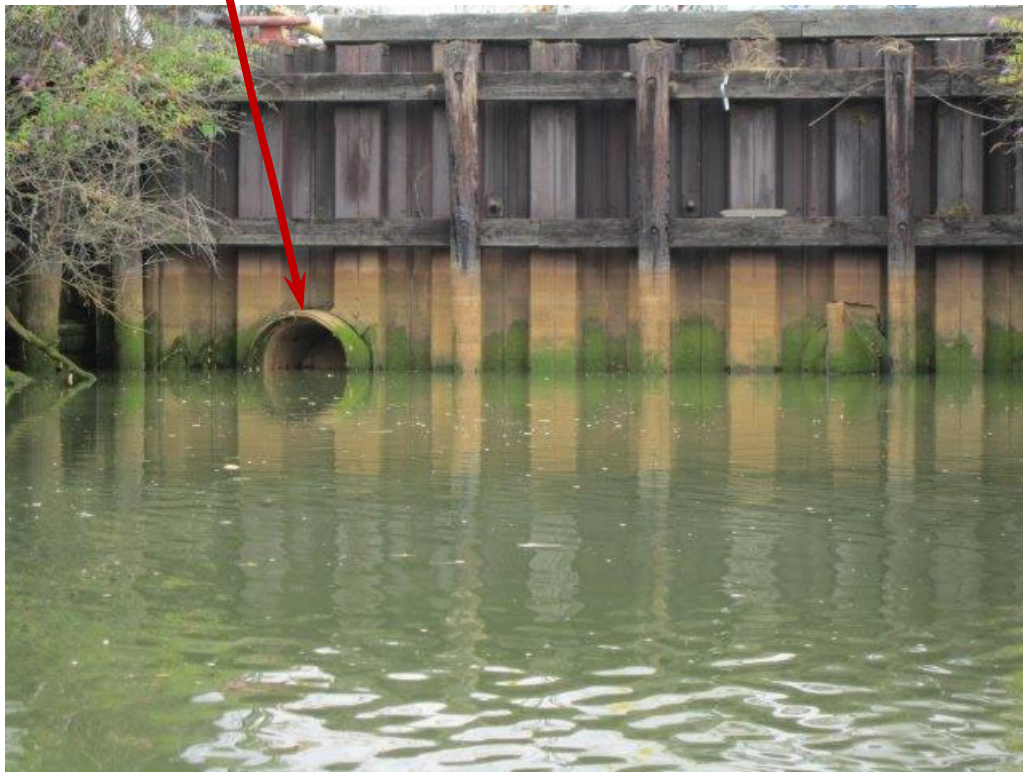
2062-02: Outfall at High Tide

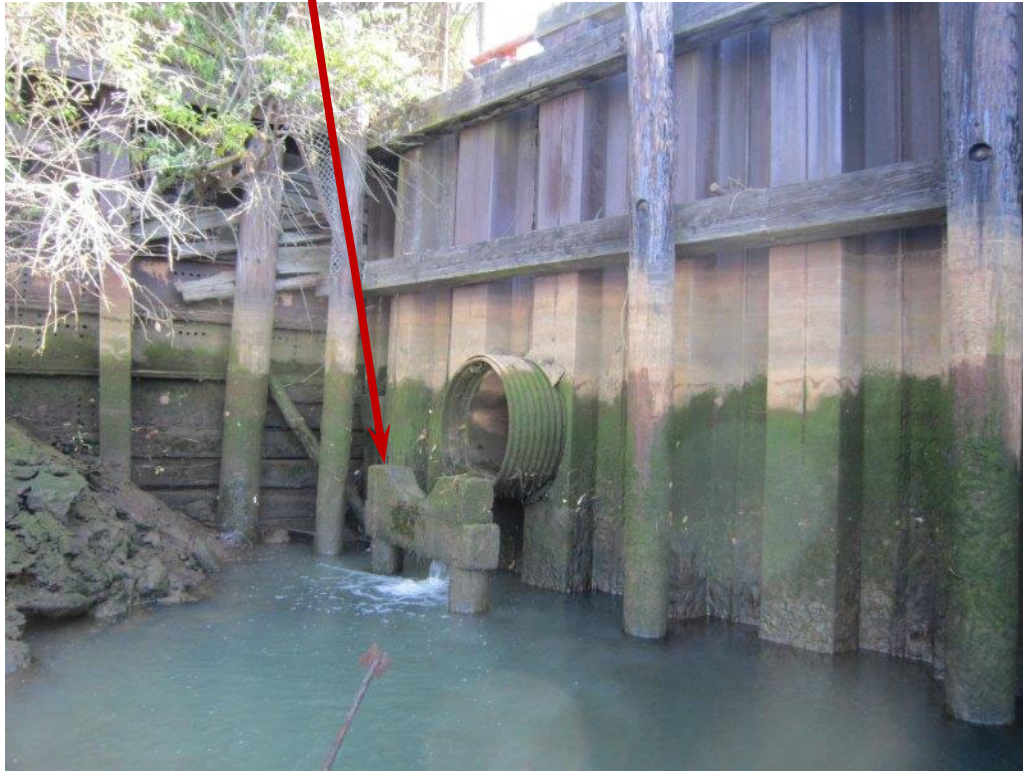
2062-03: Unused Support

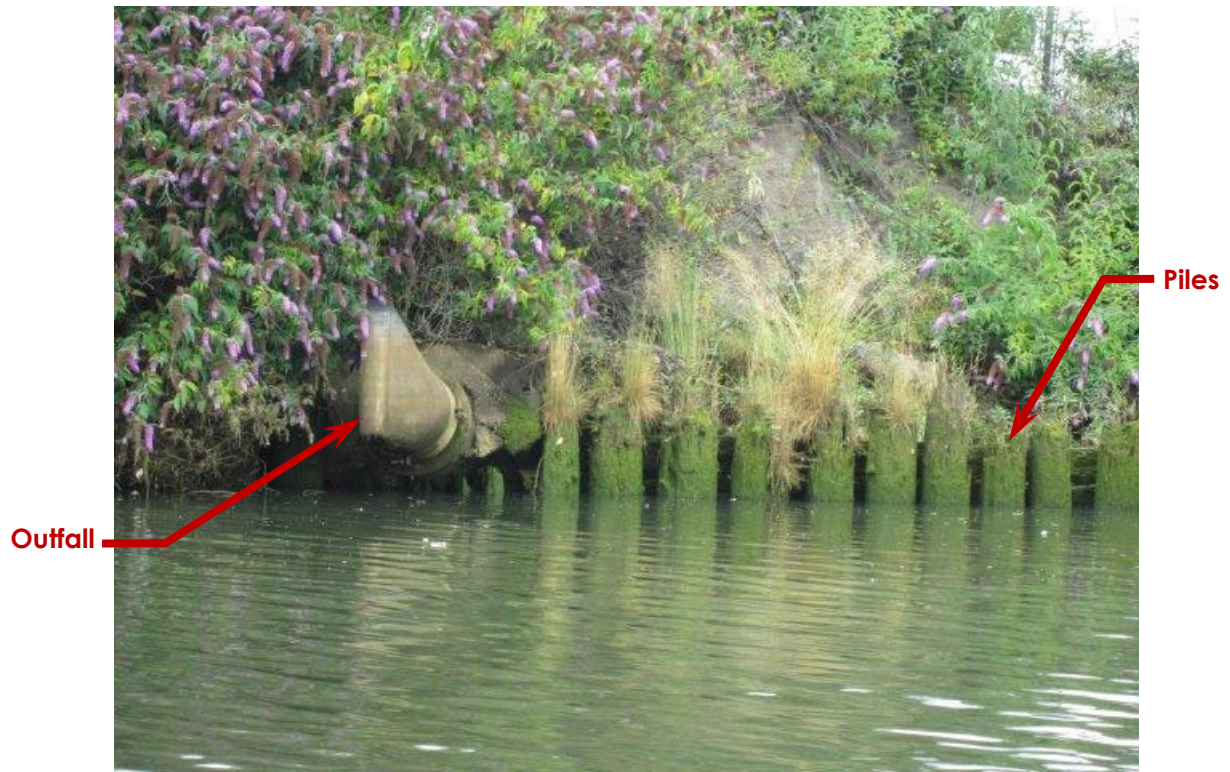
- The outfall is supported on and overhangs timber piles and lagging along the shoreline (Photos 1 and 2).
- Pipe is 20-in diameter, flanged steel pipe outfall diffuser with duckbill valve and concrete collar/armoring (Photo 3).
- Exposed top section of the timber piles and lagging are deteriorated.
- Outfall appears to be operational.

2077-01: Outfall at High Tide

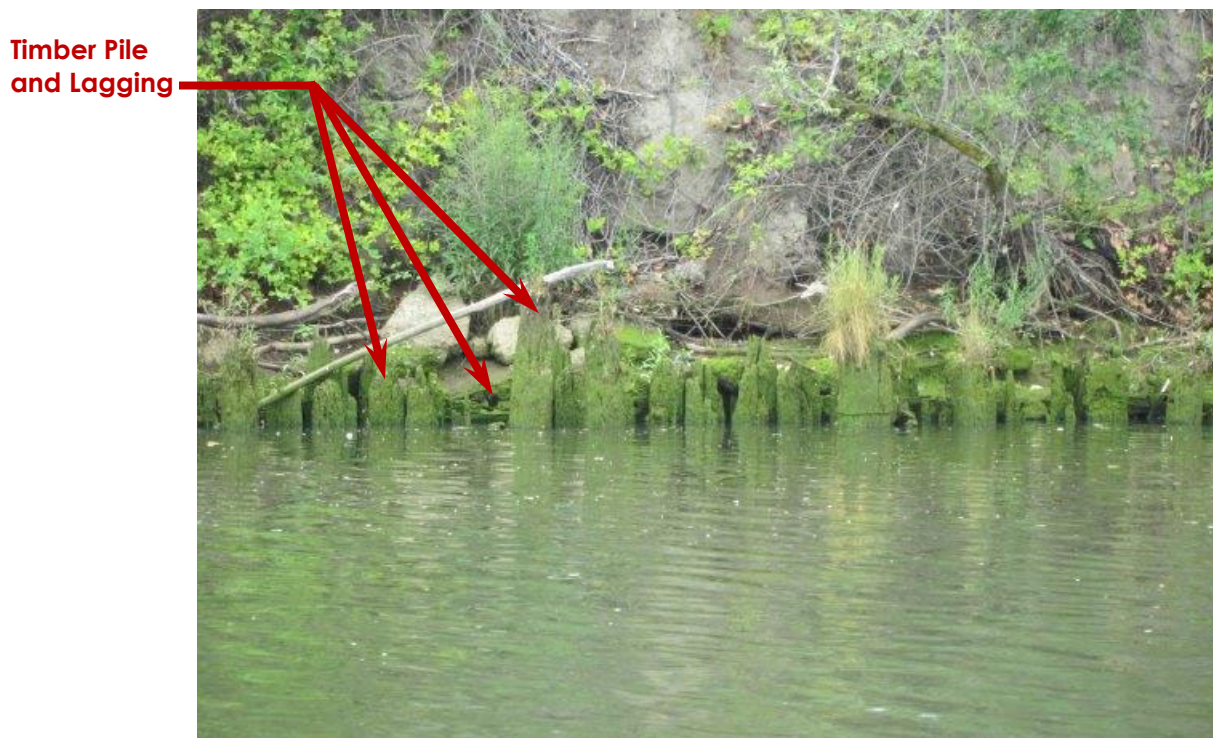
2077-02: Shoreline Timber Pile Bulkhead

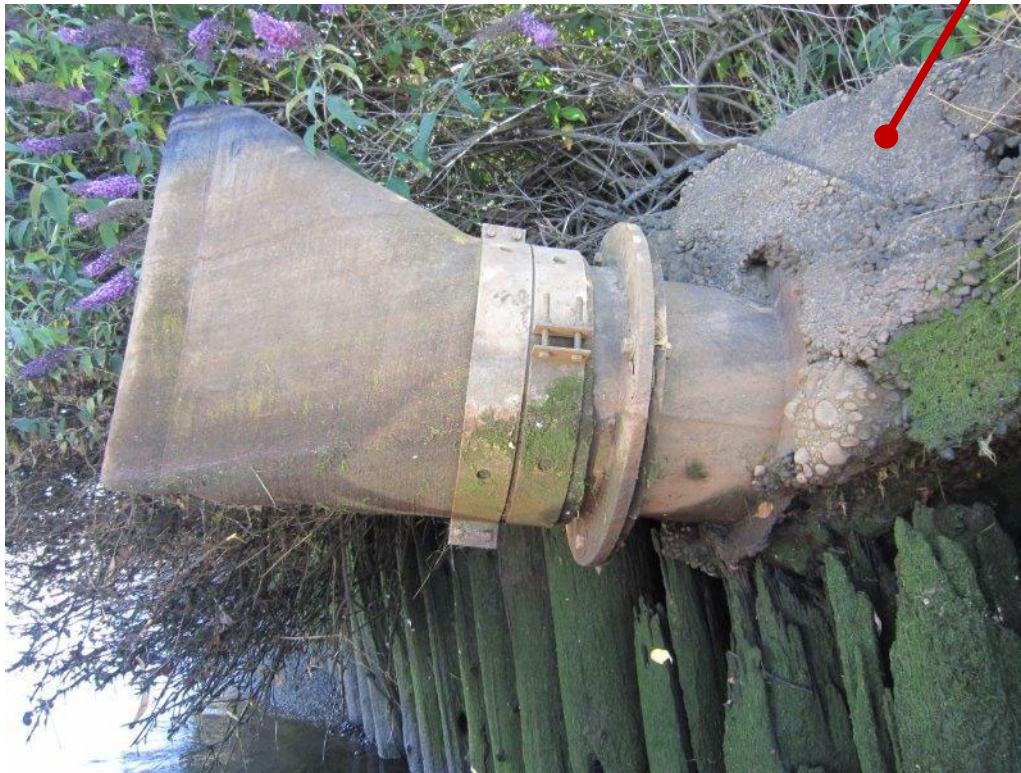
2077-03: Support

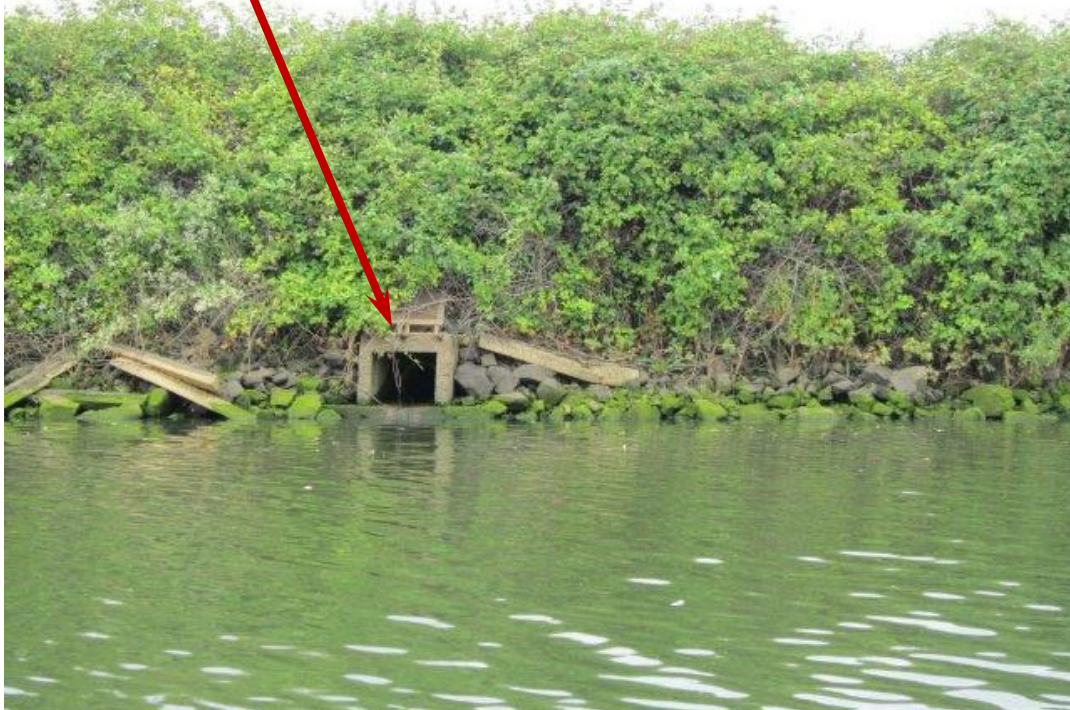
2073-01: Outfall Box at High Tide

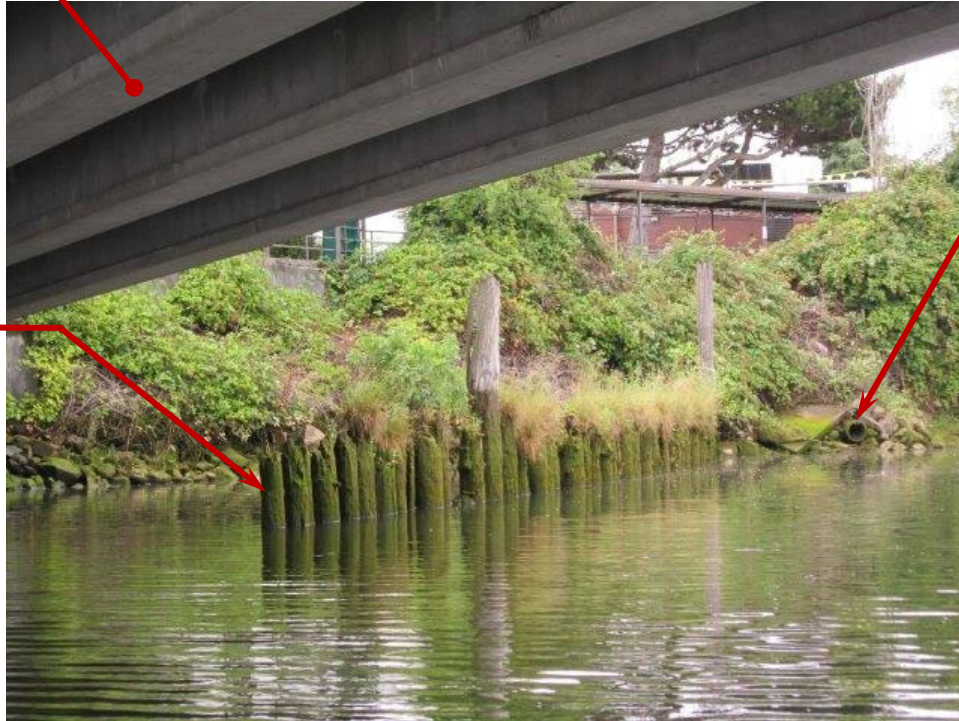
Photo 2092-01: Outfall (Looking East)

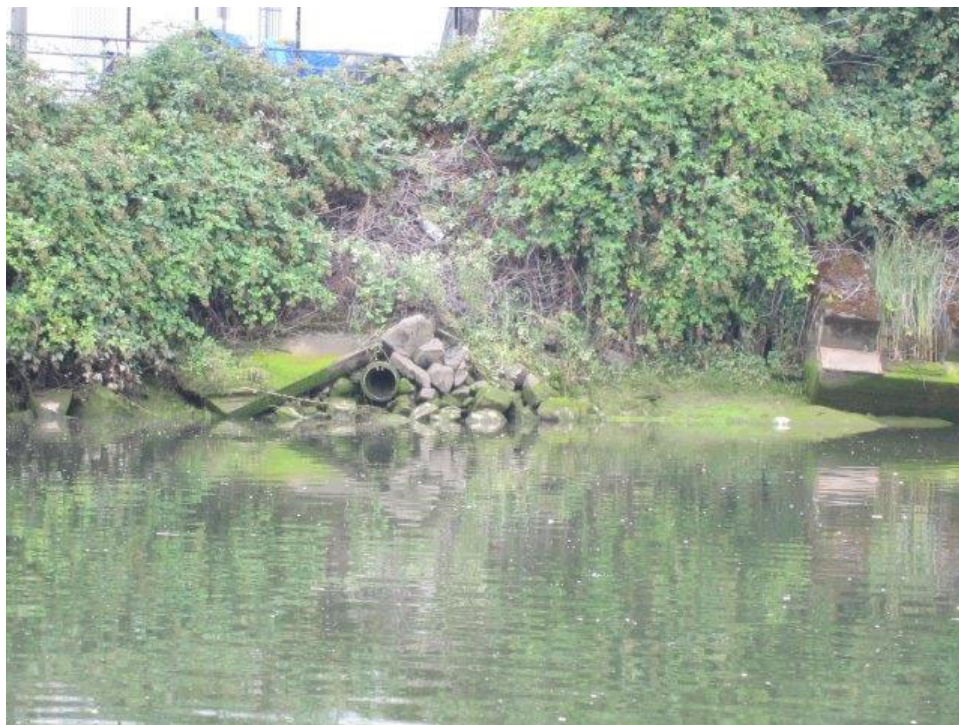
Photo 2092-02: Outfall (Looking East)

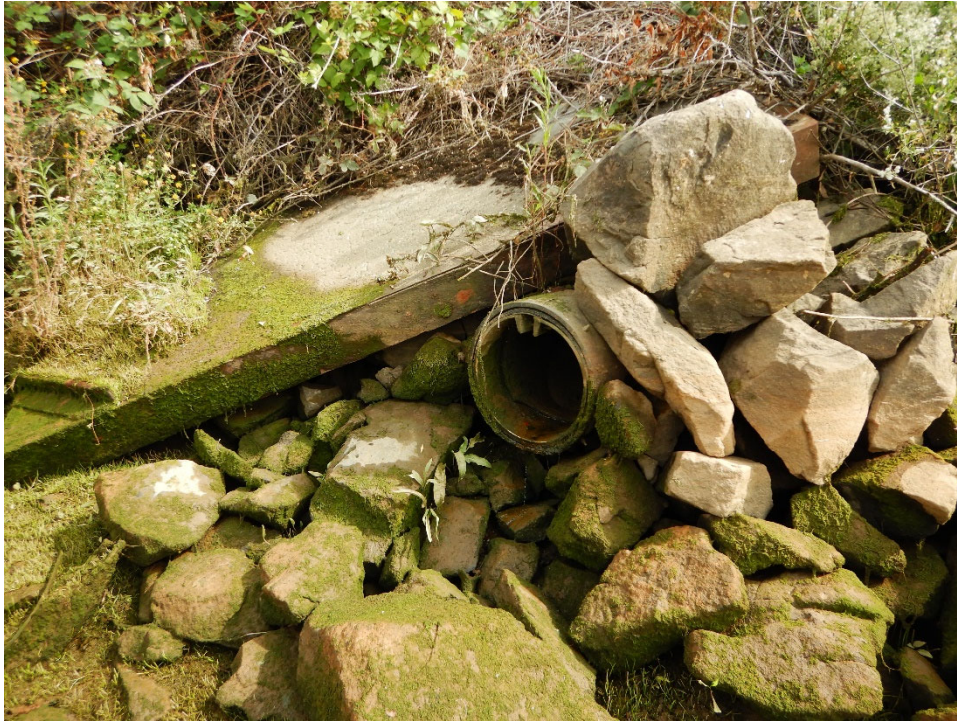
Photo 2092-03: Outfall at Low Tide

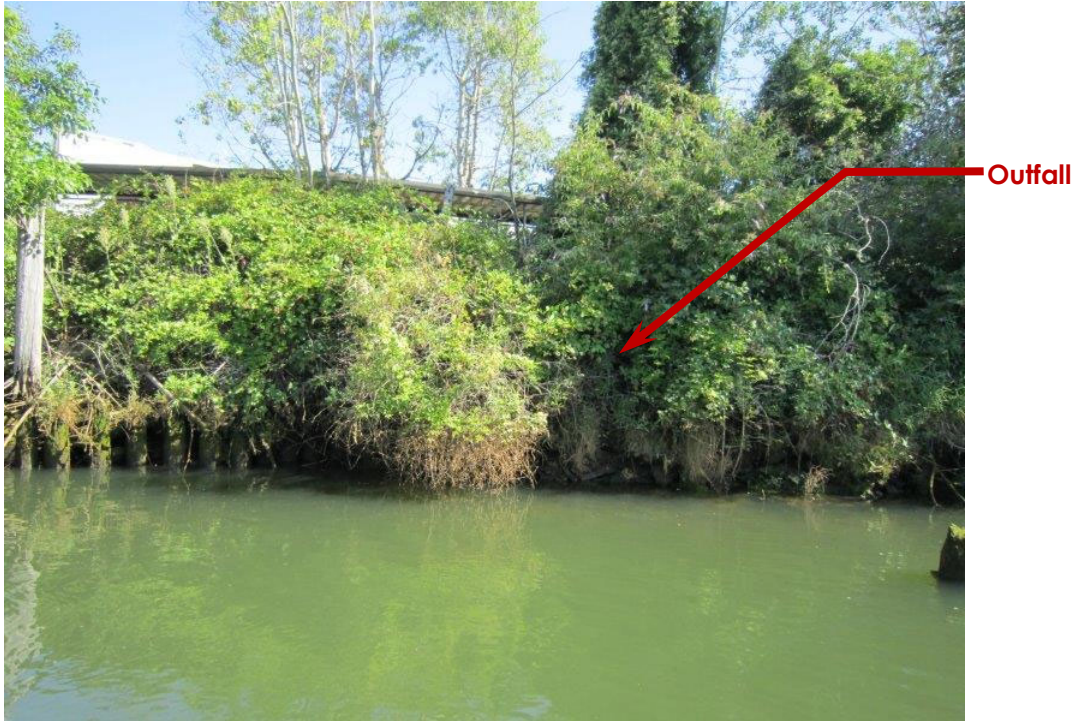
2096-01: Outfall Location

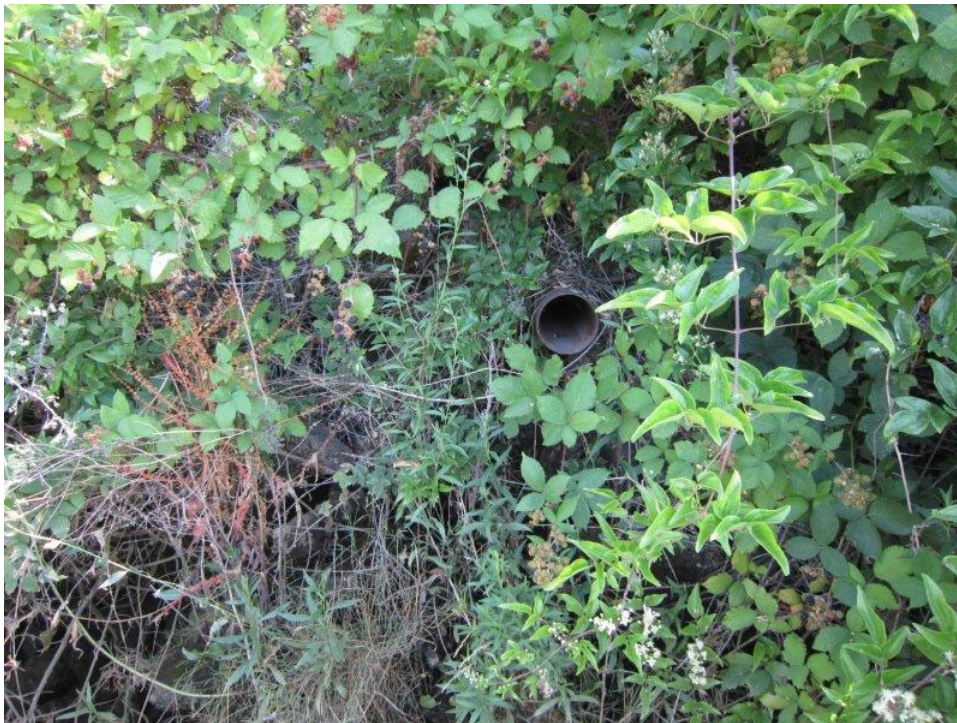
2096-02: Outfall

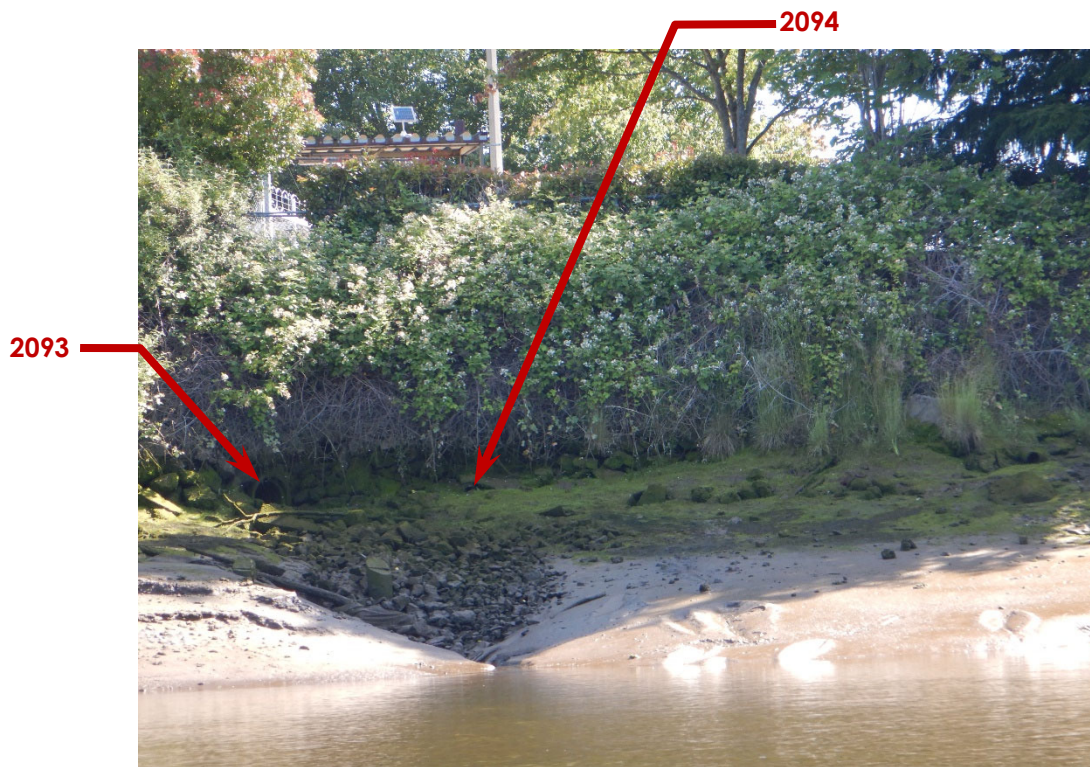
Photo 2093-01

- No obstructions observed.
- In proximity of groin timber piles that are not in a sound condition.

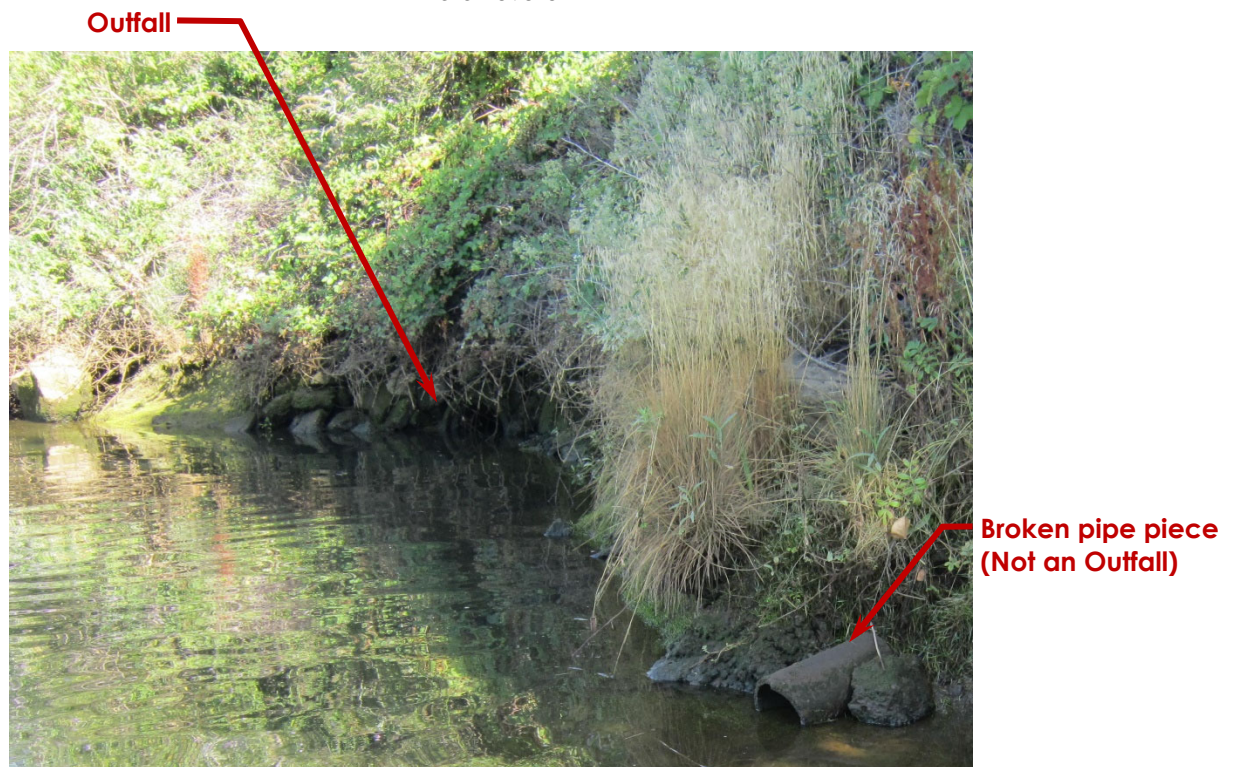
Photo 2093-02: Outfall (Looking Northeast)

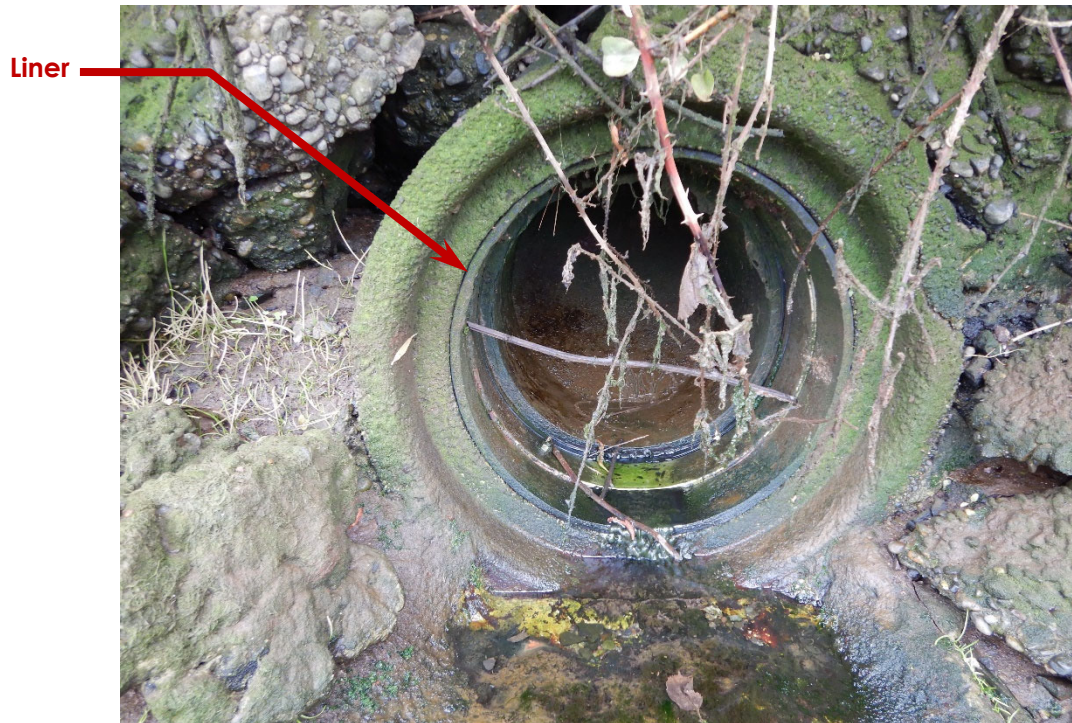
Photo 2093-03: Outfall Close Up

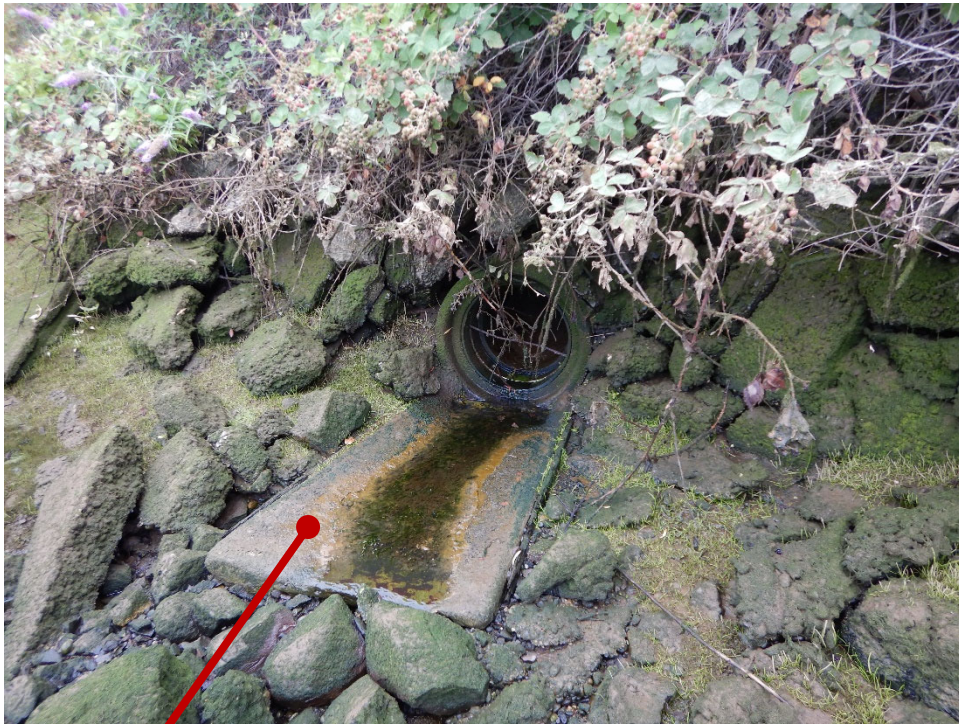
Photo 2093-05: Outfall at Low Tide

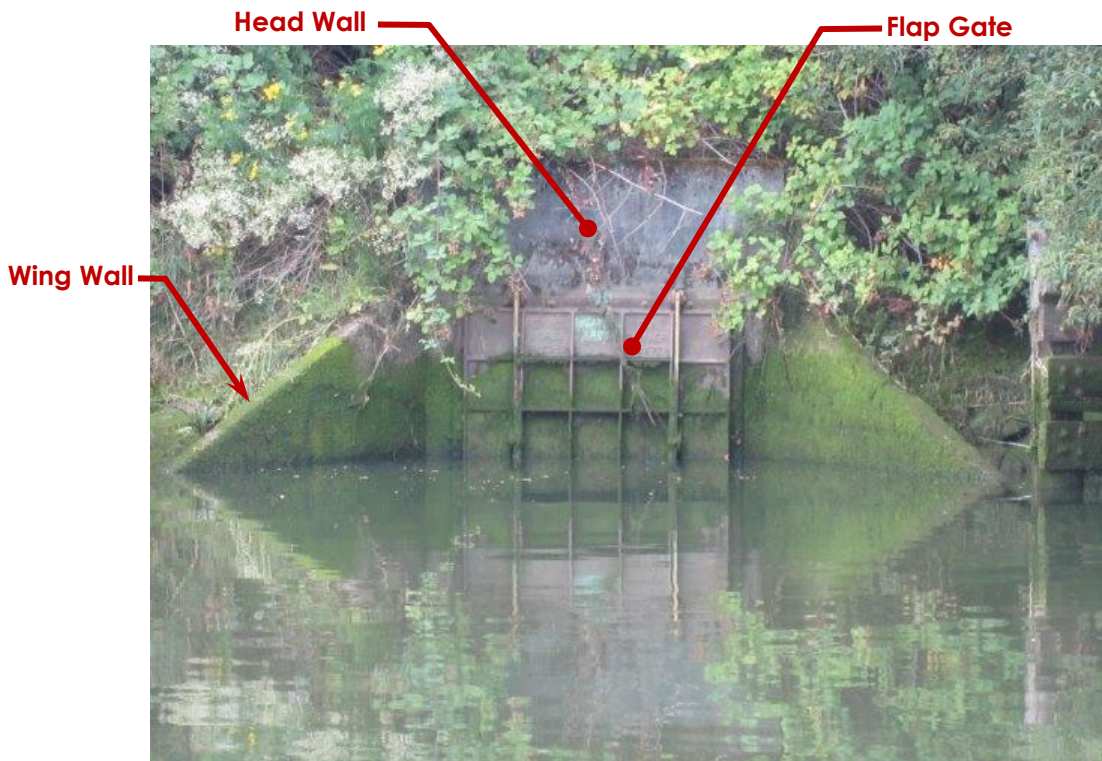
- Concrete culvert consists of concrete head wall, wing walls, and 72-in x 72-in flow control cast iron flap gate. Concrete apron is timber pile supported (Photos 1 to 4).
- The condition of the culvert could not be observed.
- On the north and south sides are timber fencing consisting of timber piles/posts and horizontal slats. Behind the fence is quarry spalls (Photos 1 and 3).

Photo 2095-02: Close Up of Culvert

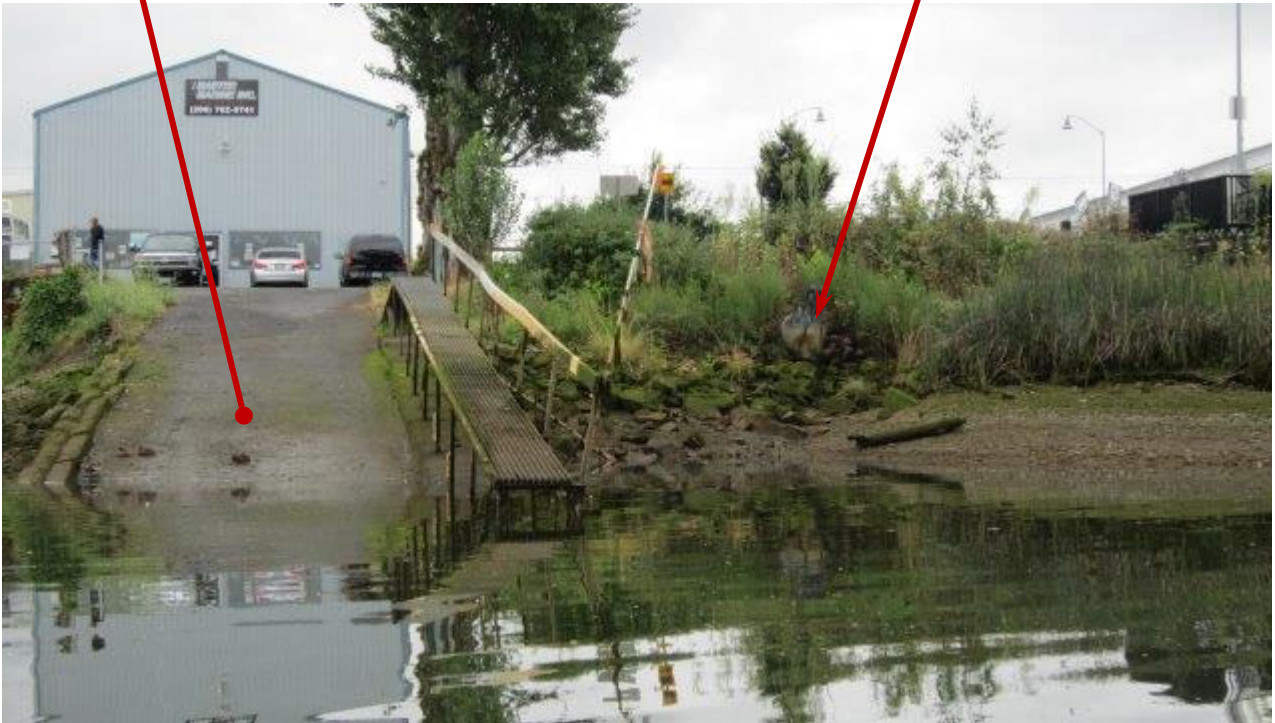
- Outfall with duckbill valve near the shoreline supported on a mound of quarry spalls (Photos 1 to 4).
- Approximately 24" diameter concrete pipe supported by quarry spalls and apron.

Photo 2215-01: Outfall (Looking West)

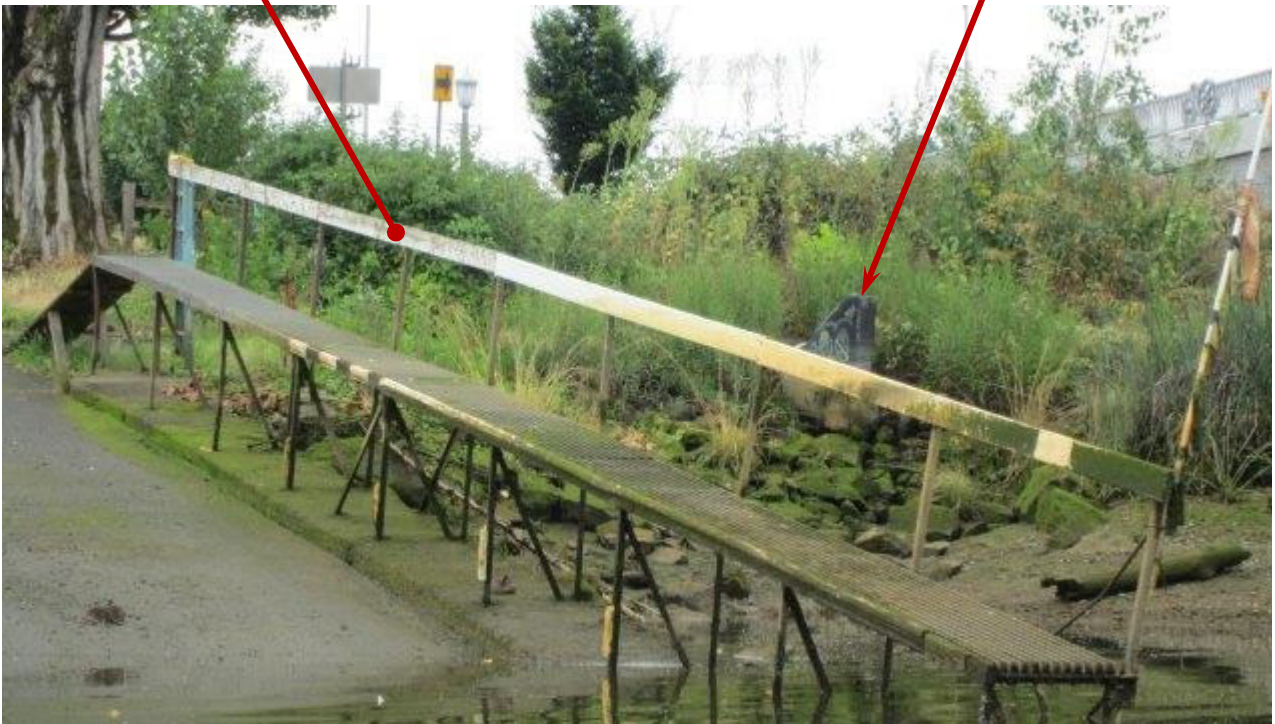
Photo 2215-02: Outfall (Looking Northwest)
